**SUBJECT** INVESTIGATION INTO ACCIDENTS

The aircraft involved was a BN-2A-27 Islander VP-FAY owned by the Falkland Islands Government and commanded by Capt. J. Kerr.

The accident/incident occurred on December 22nd at 14.50 hours on the completion of landing run at Green Patch.

Report on the accident to Islander Landplane VP-FAY at Green Patch

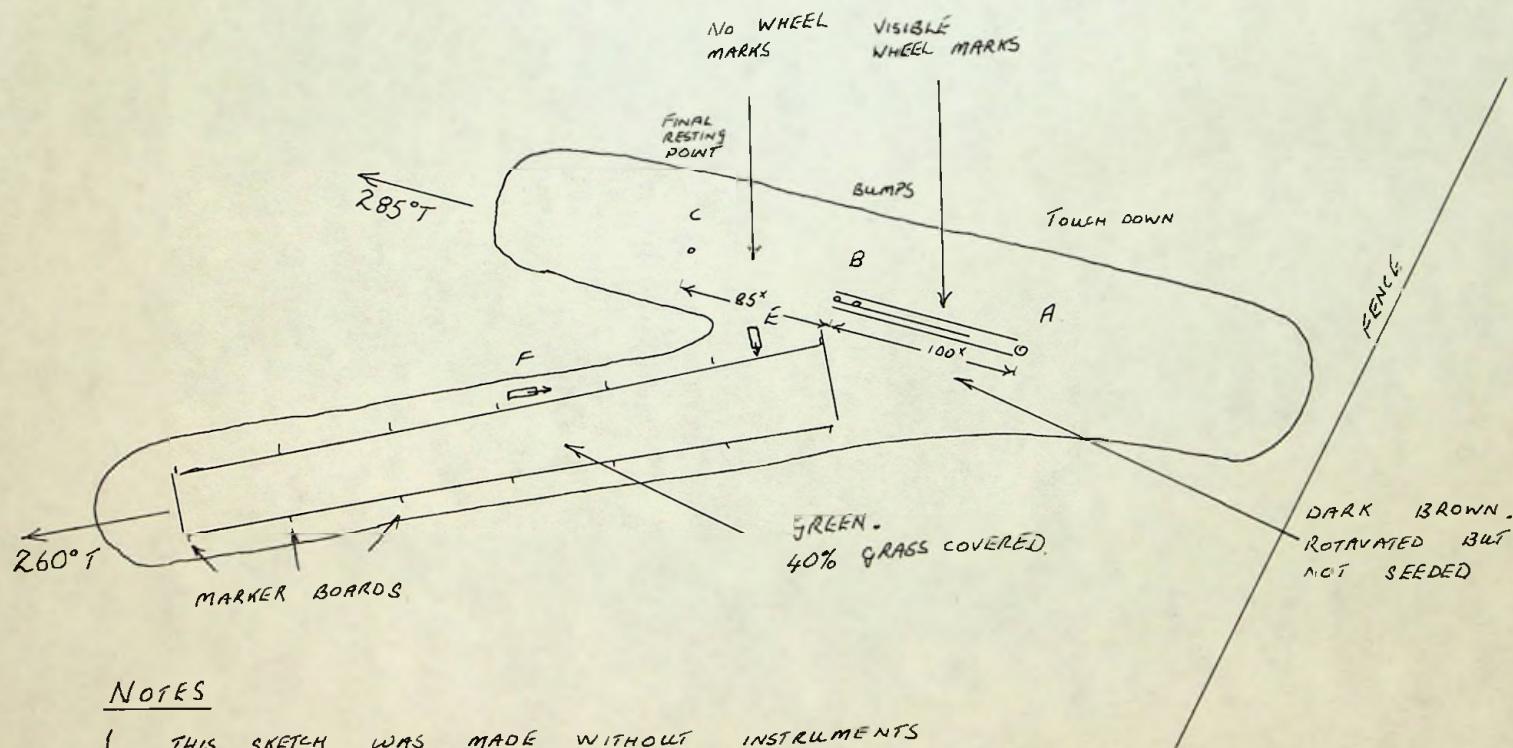
SKETCH BY LT COL ACLAND, ROYAL NAVY

1. The primary cause of the accident was that the aircraft was landed on ground that was not fit for aircraft operation.

The pilot self on arrival at Green Patch observed two strips arranged for best advantage in consideration of varying wind direction. One strip was observed to have a number of small white markers in a bottle neck pattern. The pilot had been advised that these marked off bad ground on the (most) used<sup>?</sup> strip and that in that area landings should be conducted between these sets of markers. One end of these (West) marked an end of this strip, the other end being the confluence of the strips, was unmarked as to indicate the beginning of firm ground.

The aircraft was landed in the conventional manner and in the course of the landing role the nose wheel and associated structure sustained damage as recorded in the aircraft log; this being caused by the nose wheel ploughing into soft cultivated ground.

- (b) The landing strips should be marked both at the ends and at the sides. Oil drums at the sides should be discouraged as they present a particular hazard to aircraft.
