LIGHTHOUSE

MENGEARY POINT LIGHTHOUSE

Report following survey on 6th May, 1959

MENGEARY LIGHT

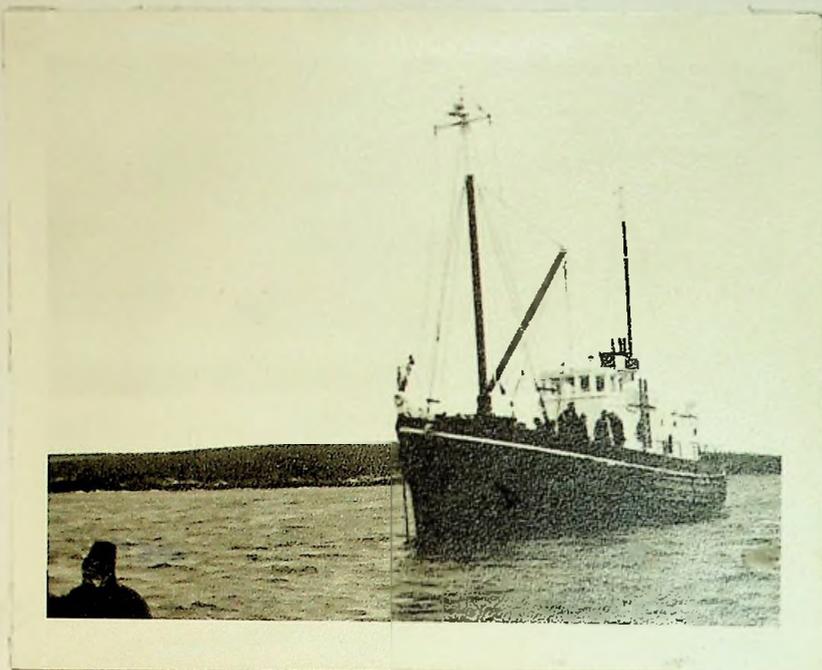
SHI-NAV-2-4-01

M. V. PHILOMEL LANDING PARTY FROM H.M.S. 'LYNX'
AT DON CARLOS BAY.
31st OCTOBER, 1964

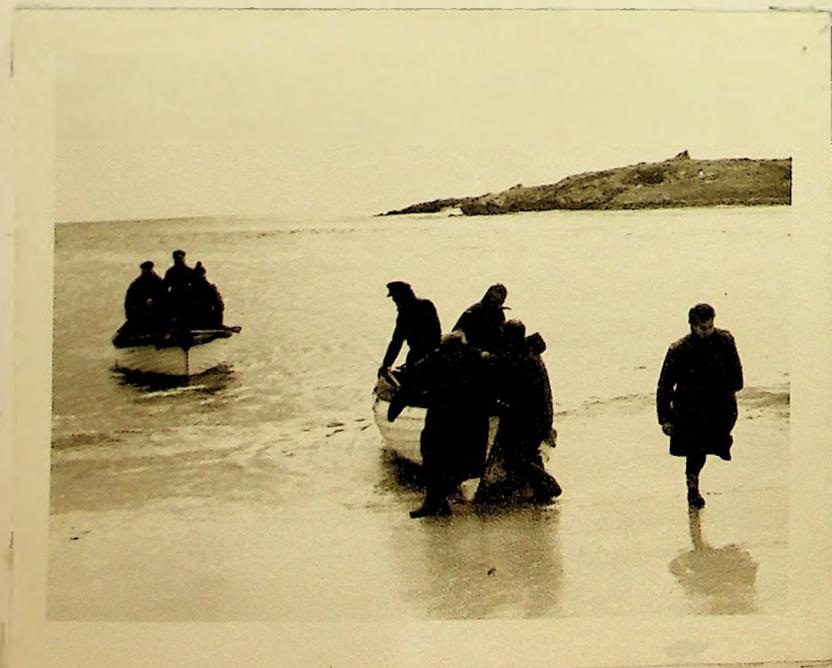
03

PARTY FROM "H.M.S. LYNX" SHIFTING OLD TOWER LATTICE CONSTRUCTION
OF MENGEARY LIGHT PREVIOUSLY BLOWN DOWN BY
H.M.S. PROTECTOR AND CUT INTO THREE PIECES
31 OCTOBER, 1964.
