ROSS ROAD – GAOL AND POLICE STATION

The original gaol and gaoler's accommodation was in the Dock Yard and is still standing today, forming part of the Falklands Historic Dockyard Museum. Construction of the new stone gaol commenced in 1868 on Ross Road and the original building is still used to date as part of the Police Station and Prison.

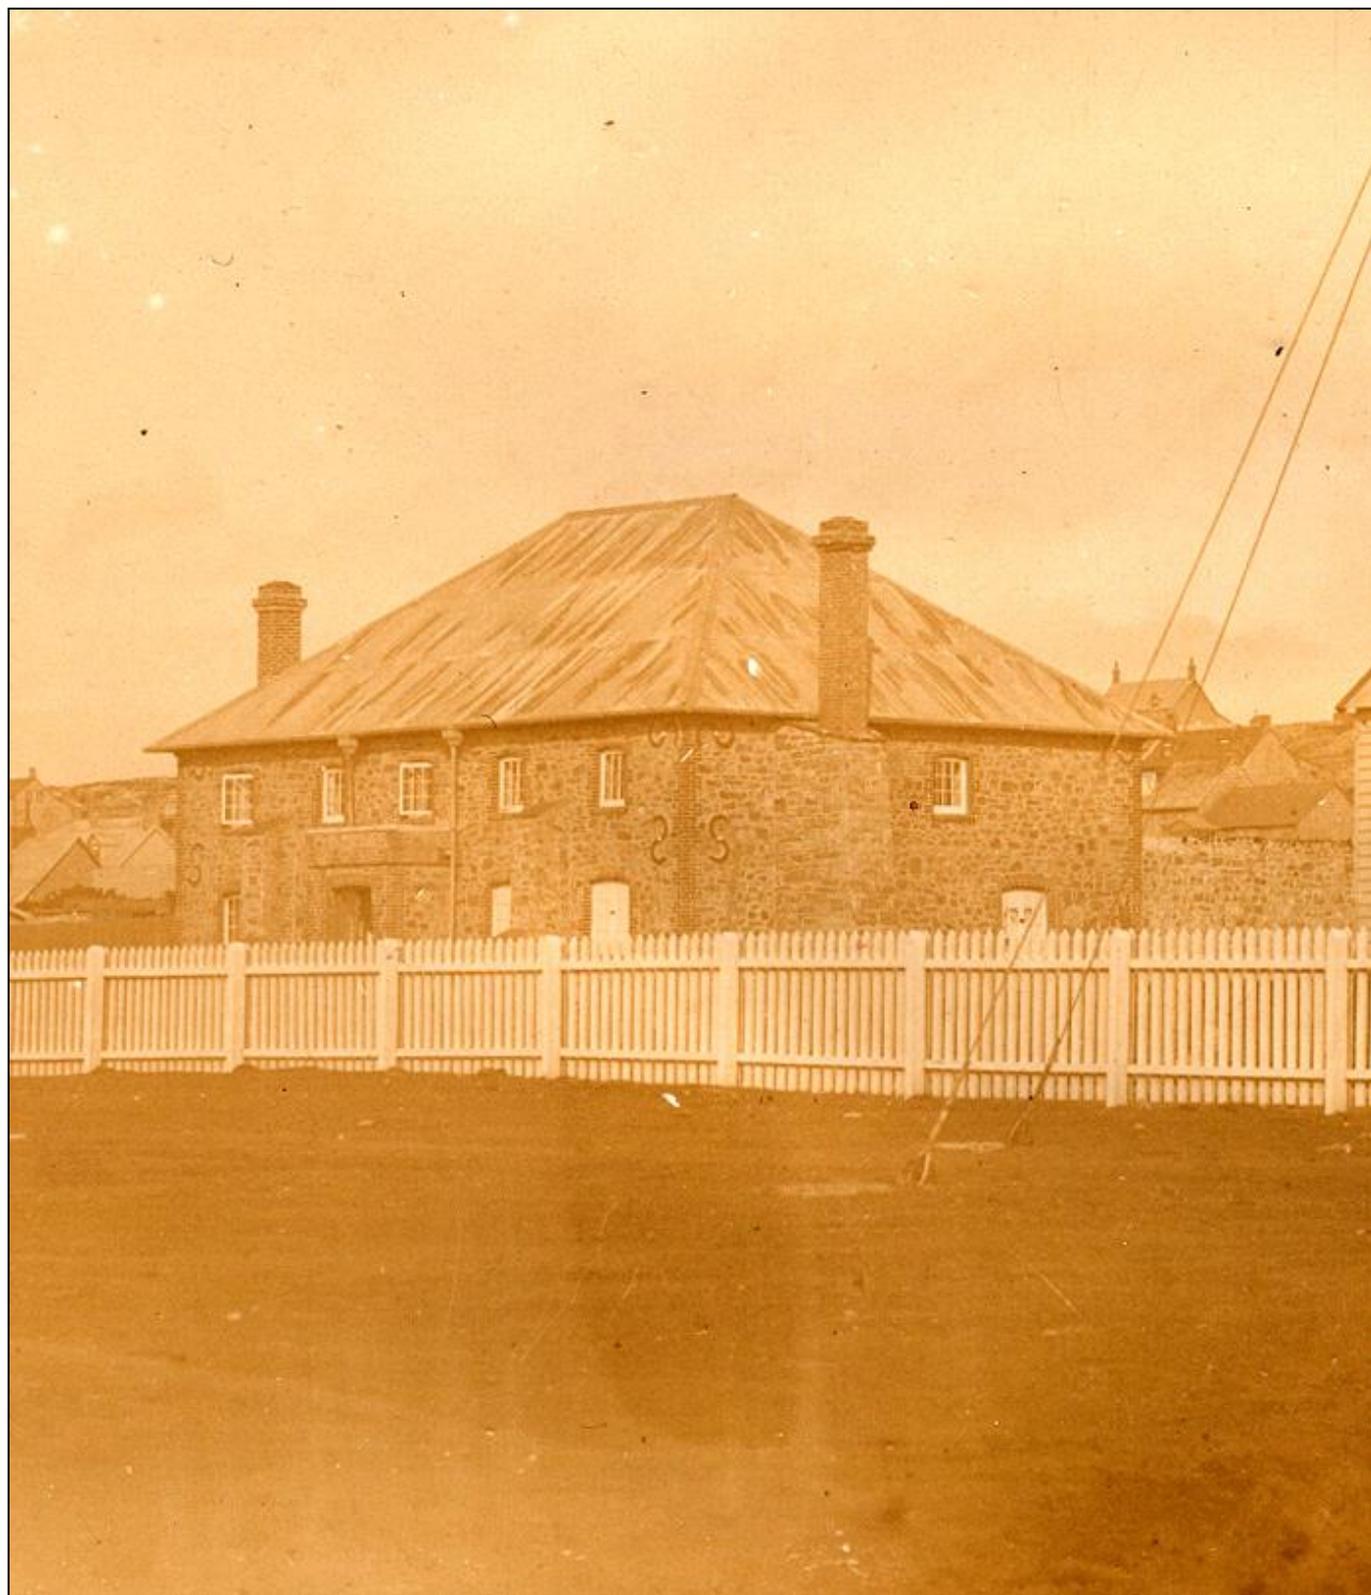
The Gaol after the fitting of the iron tye-rods – Luxton Collection

According to the verbal report made to Governor KERR by Mr TUMBER “*it appeared that the East and West walls of the Building were separating through the strain and weight of the roof, and that the rottenness of the ends of the Joists was caused by their not being properly protected when the Gaol was built.*” It was recommended that the building be measured and that a sufficient number of iron tye-rods be ordered. [P2: 349]

2. I have had the building surveyed by competent workmen who report that there are cracks extending through the substance of the walls at both ends; that the material used as mortar has not sufficient lime, and is wanting in cohesion, and that the wood work at all points of contract with the walls is rotten or unsound.

3. It is recommended that strong iron tie rods should be used to brace and keep the walls together, and that iron girders should be placed under the beams and sleepers...the chimneys have to be taken down, the arches supported and repaired, and the rotten joists and flooring removed and replaced by new materials.” [B22; 31]

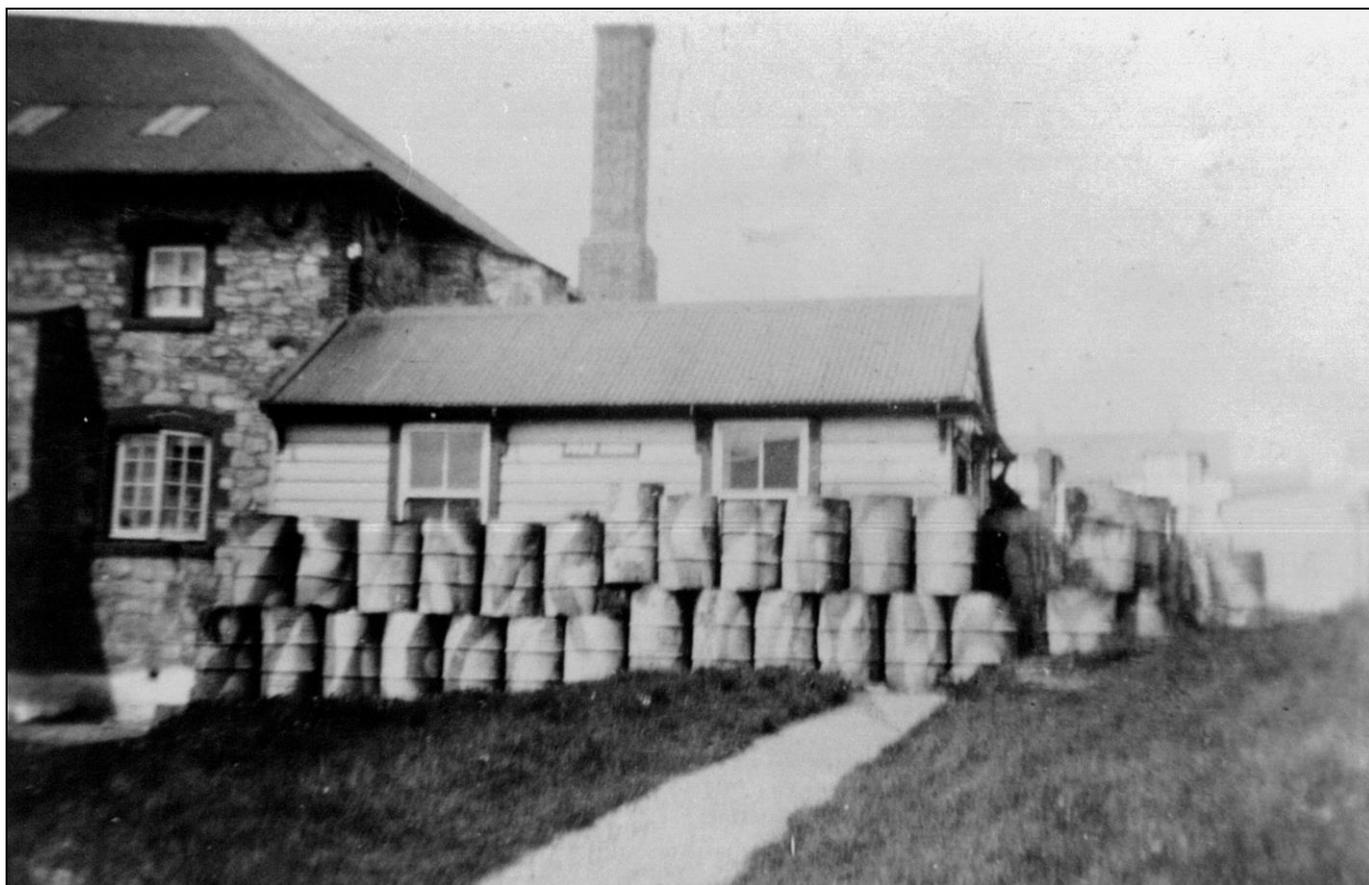
Defences around the Police Station in 1942
